CONTAINER LOADING REPORT	Client:		Conclusion PENDING
		Report Date:	29 May 2017	
		Inspection No.:		Page 1 of 10
		Form No.:

Service Performed:	Container Loading Supervision

Client:		
Product Description:	Refer to section A	
P.O. No.:		
Letter of Credit No.:	/	
Destination Country:	Russia	
Date of Loading:	28 May 2017	
Time:	16:00	
Supplier:		
Factory:		
Loading Location:	Jinhua City, Zhejiang Province, China

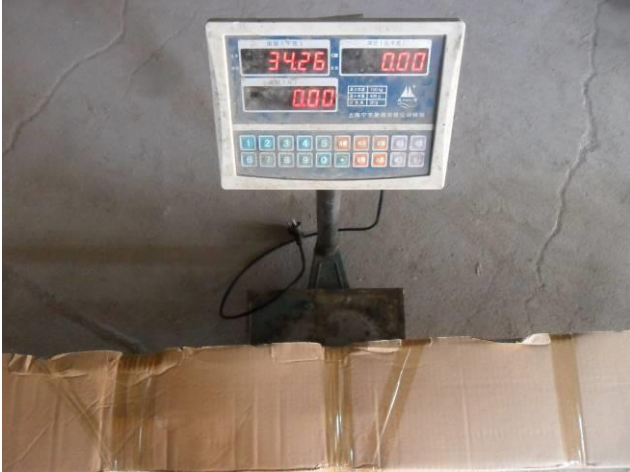
Gross weight check

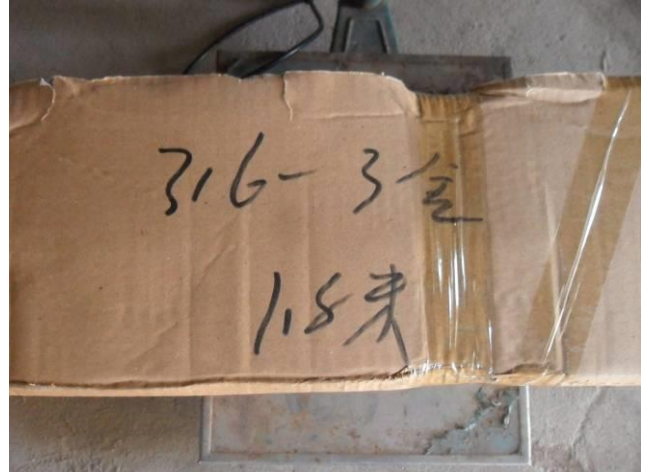
Marking on carton

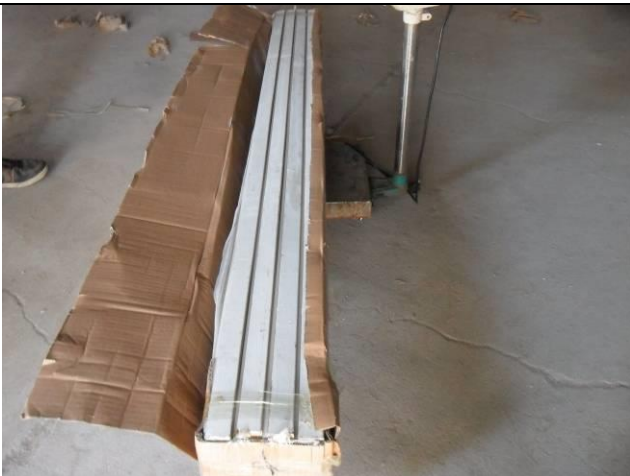
Unit packing

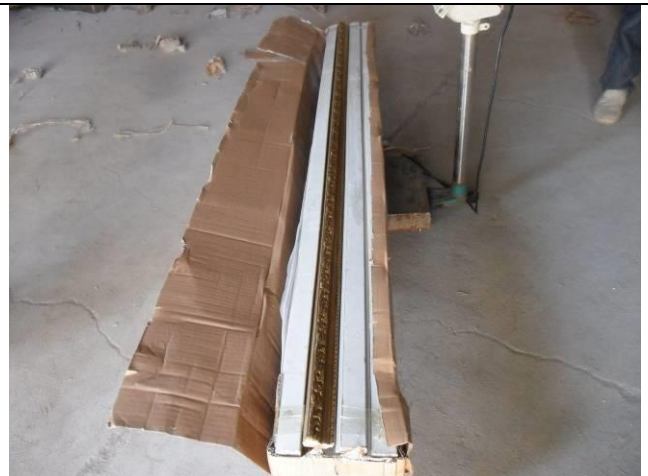
Unit check

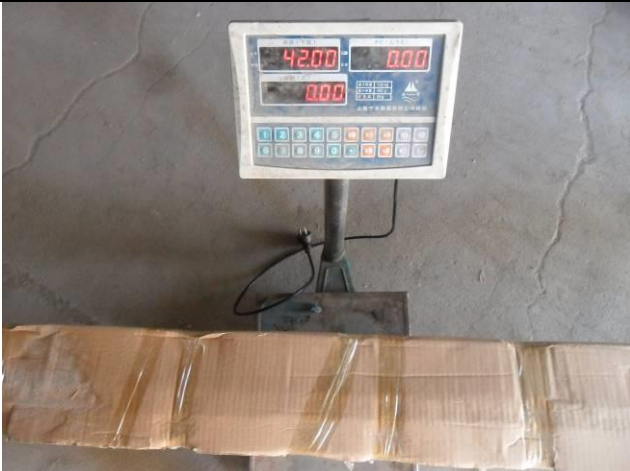
Gross weight check

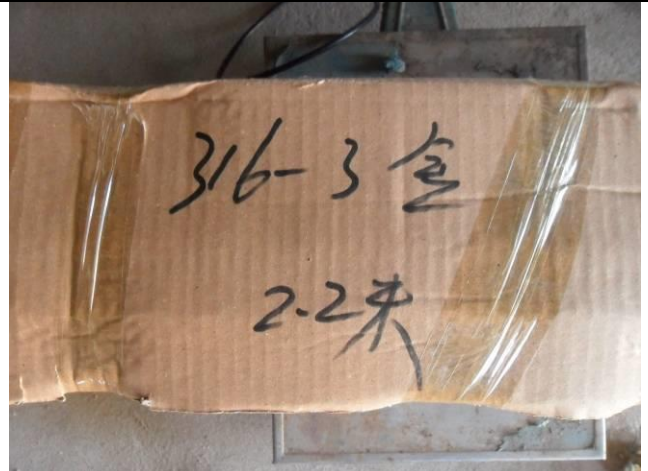
Marking on carton

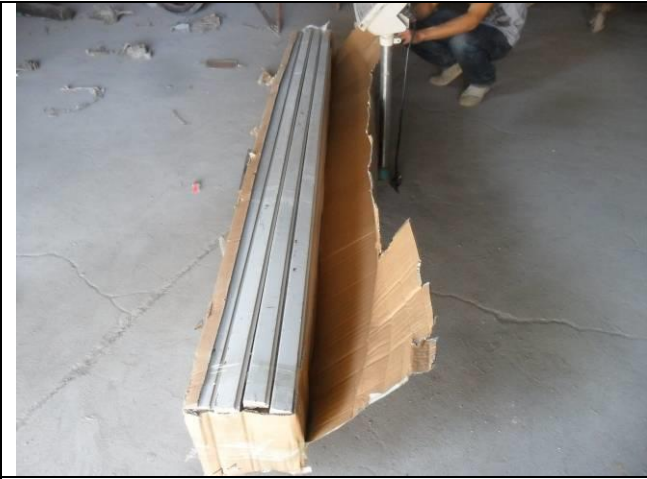
Unit packing

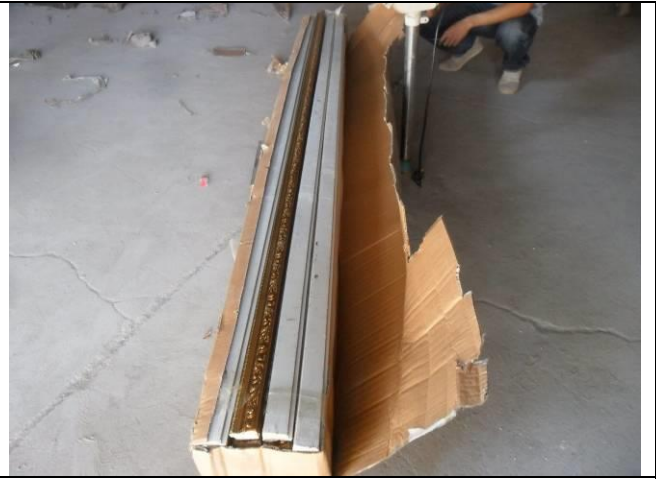
Unit check

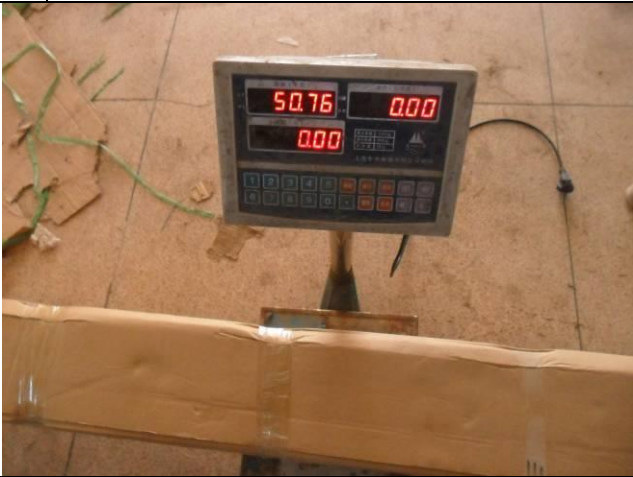
Gross weight check

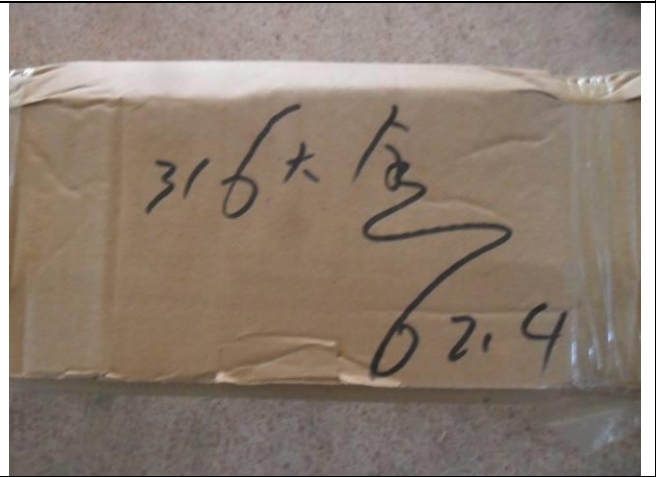
Marking on carton

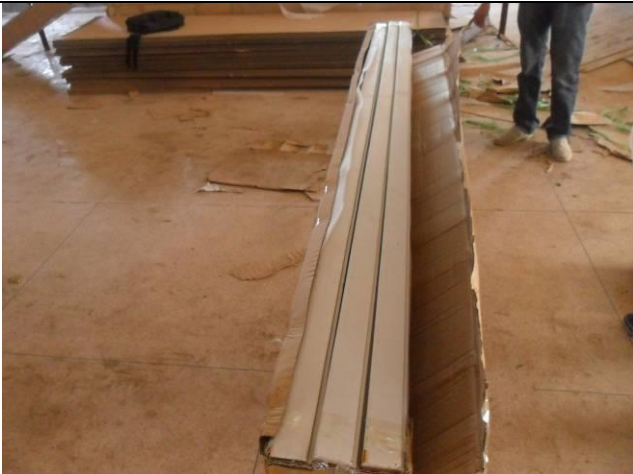
Unit packing

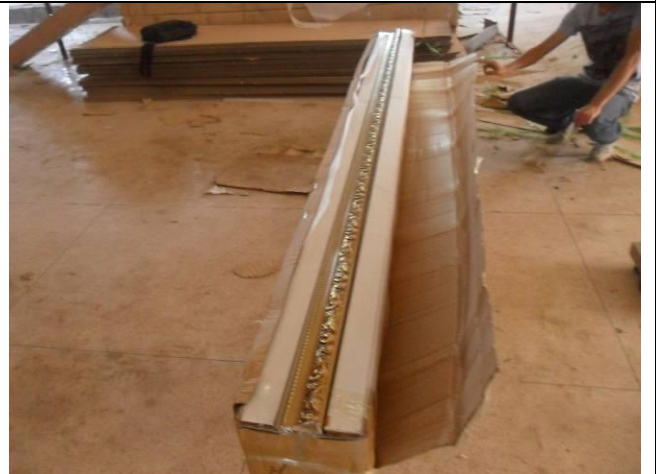
Unit check

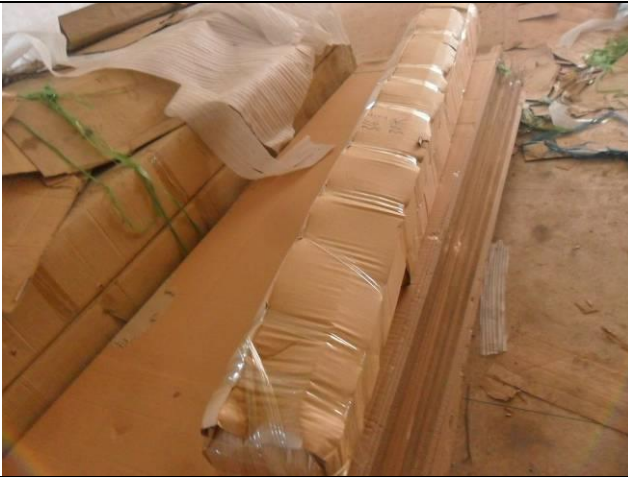
Carton packing

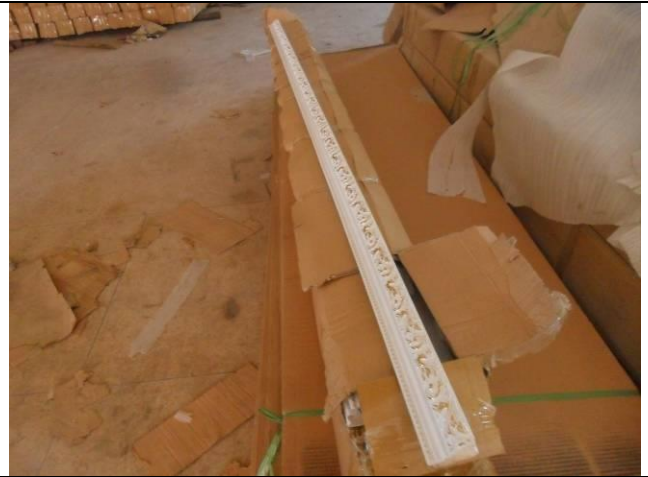
Unit check

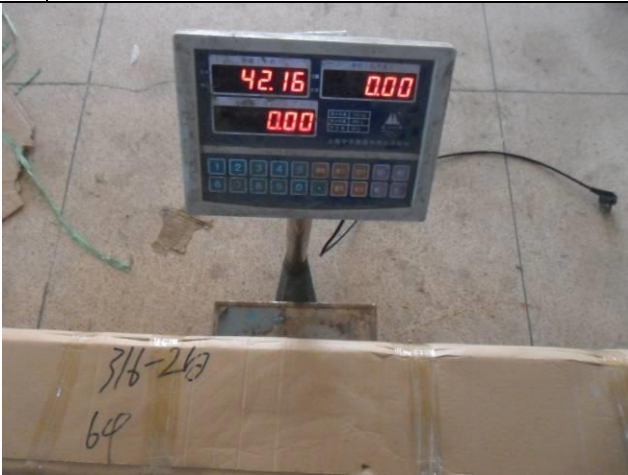
Gross weight check

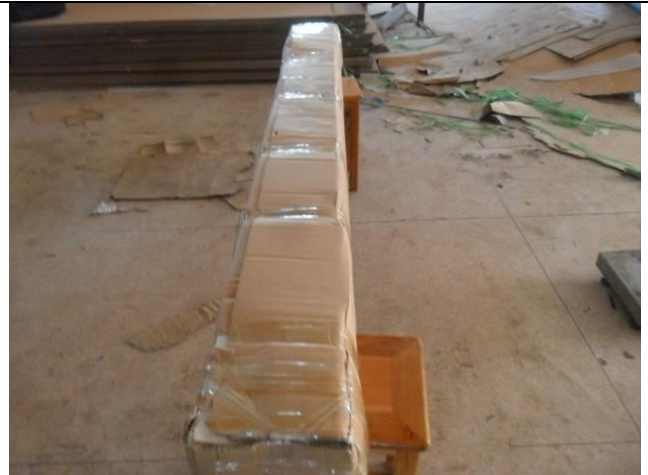
Carton packing

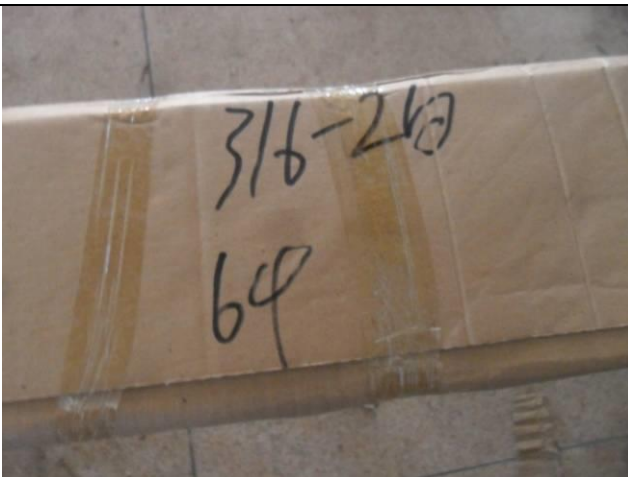
Marking on carton

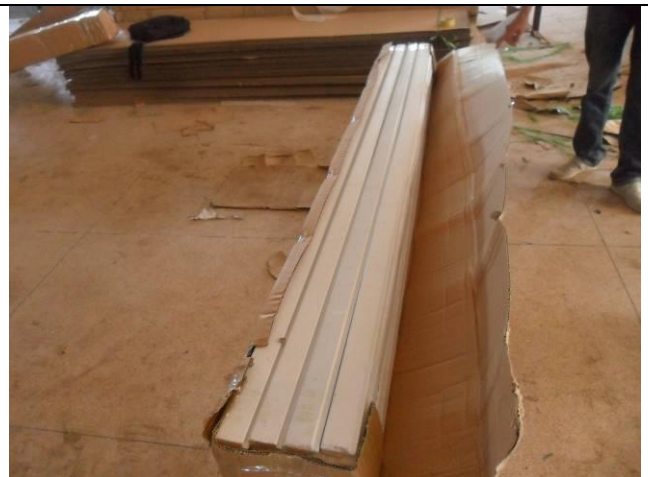
Unit packing

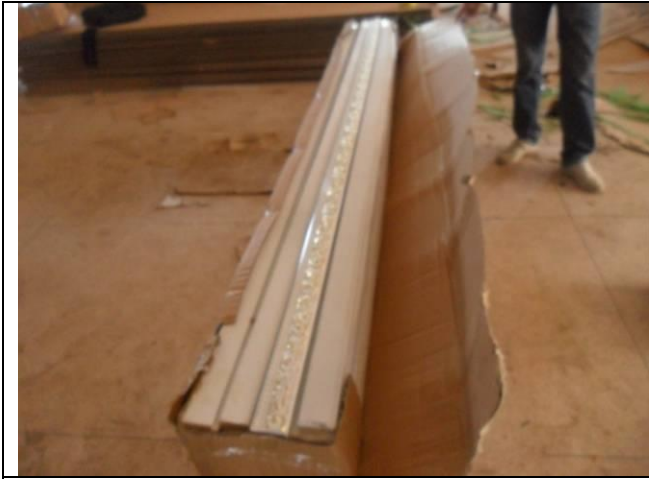
Unit check

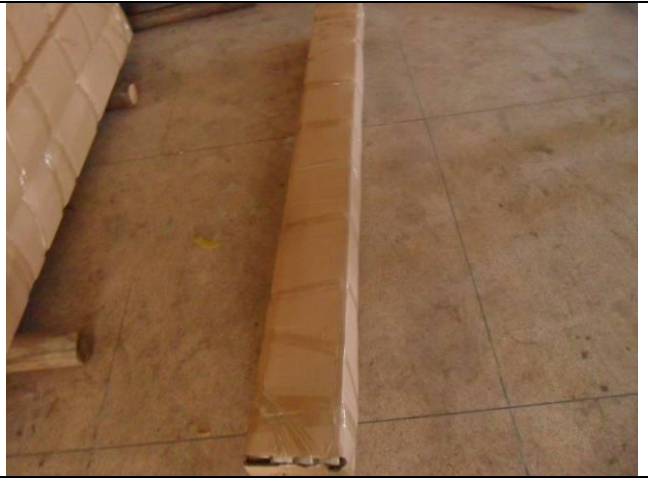
Carton packing

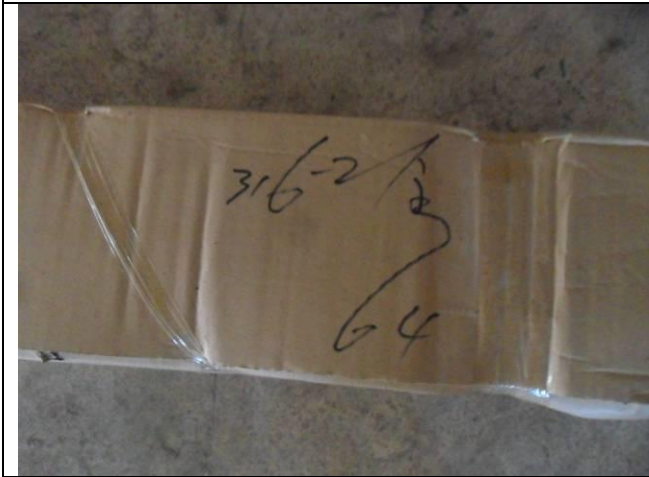
Marking on carton

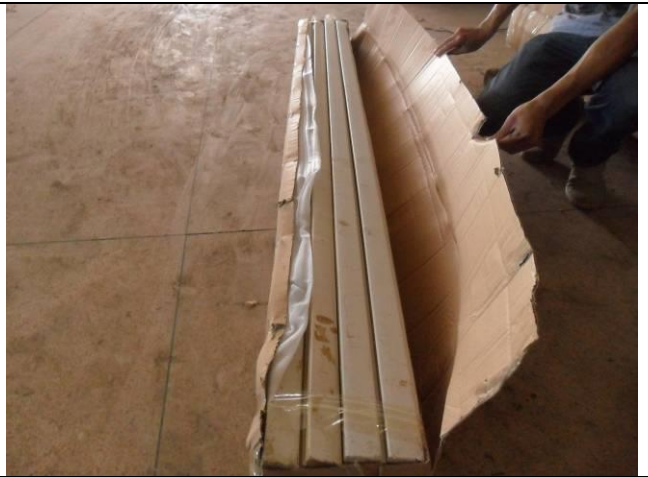
Unit packing

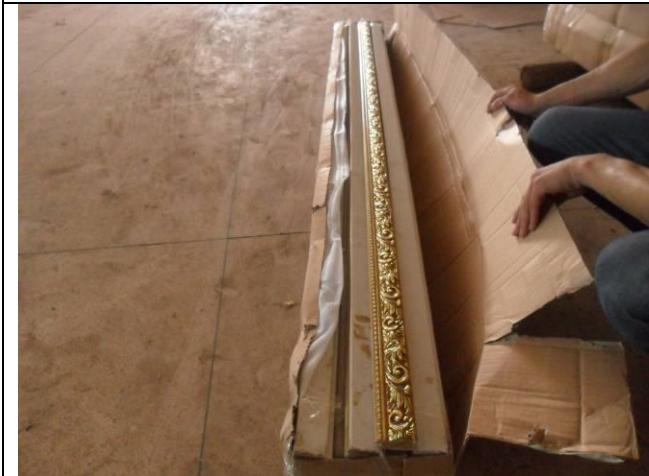
Unit check

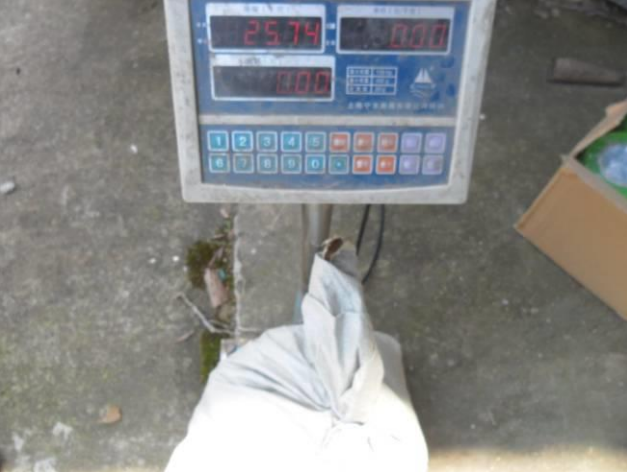
Gross weight check

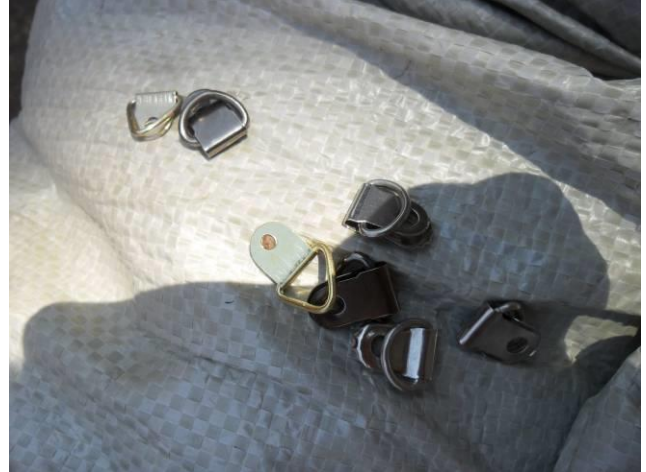
2.	There were 5 cartons tape and 1 carton metal units, which were not list in packing list loaded into container.
General Remarks:	
3.	The container had been sealed on site.
Factory Information:

Unit check

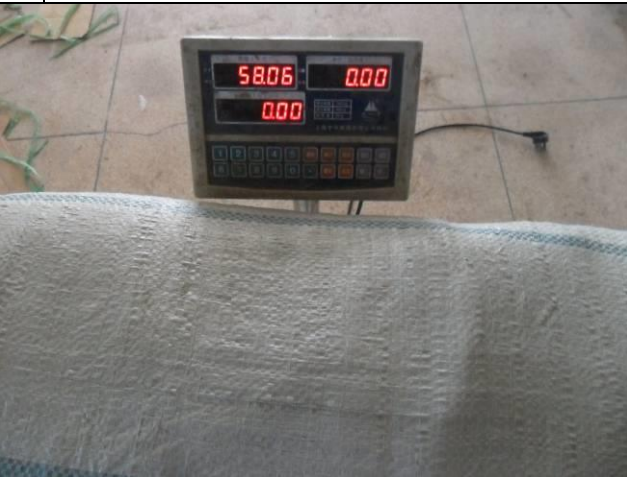
Gross weight check

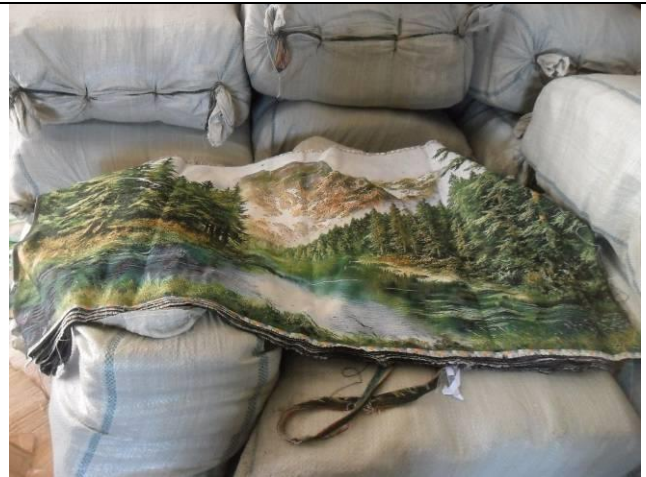
Unit check

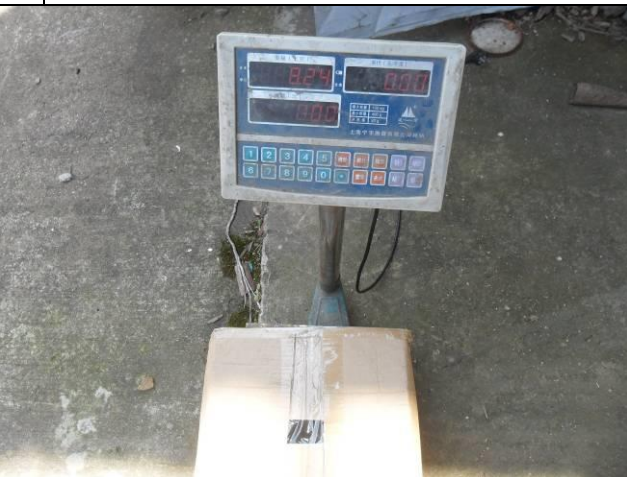
Gross weight check

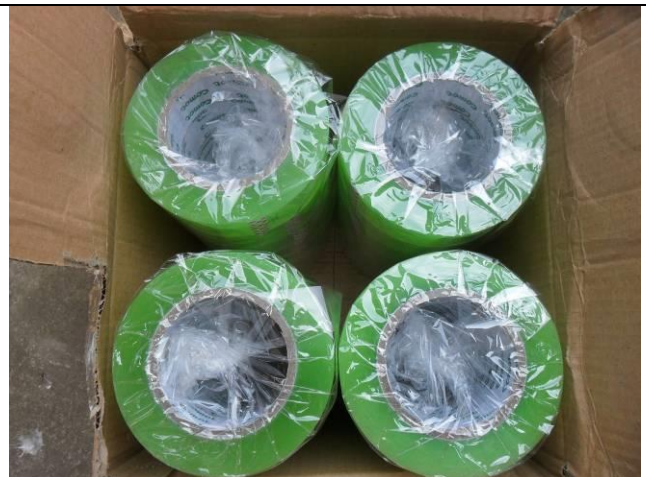
Unit packing

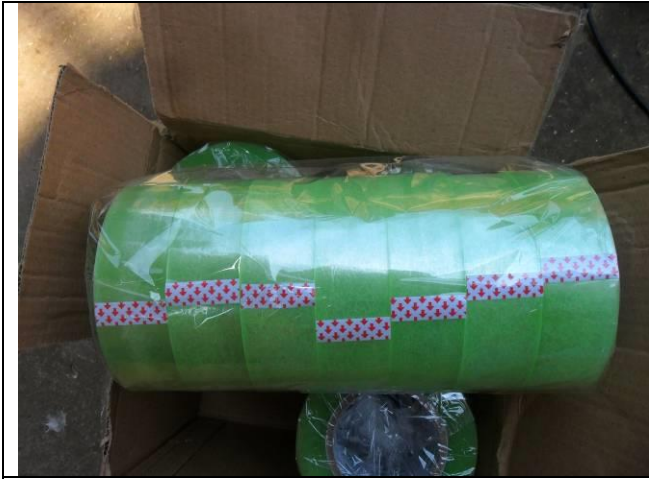
Unit check

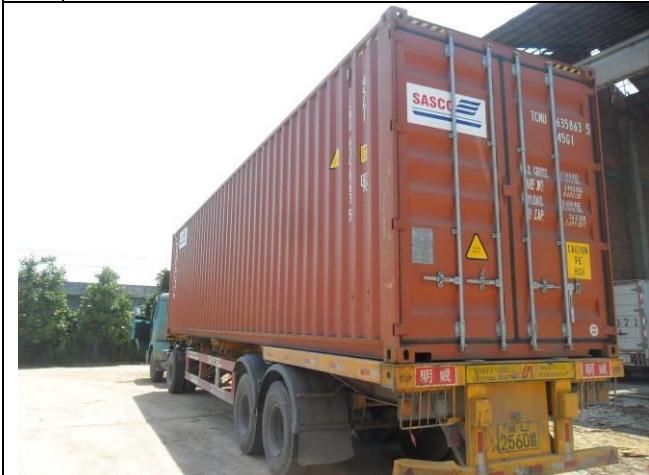
Container

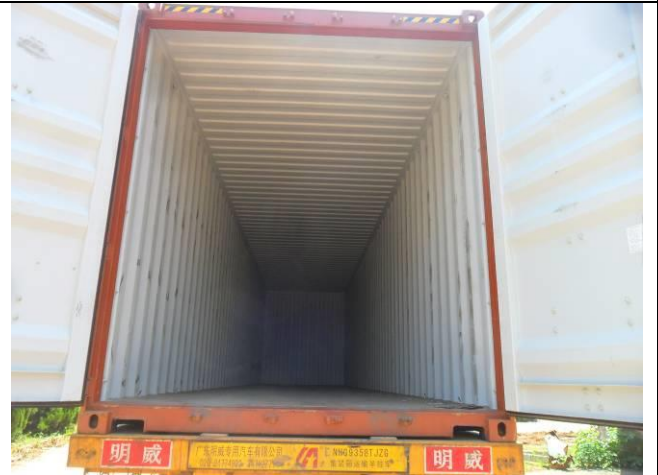
Empty container

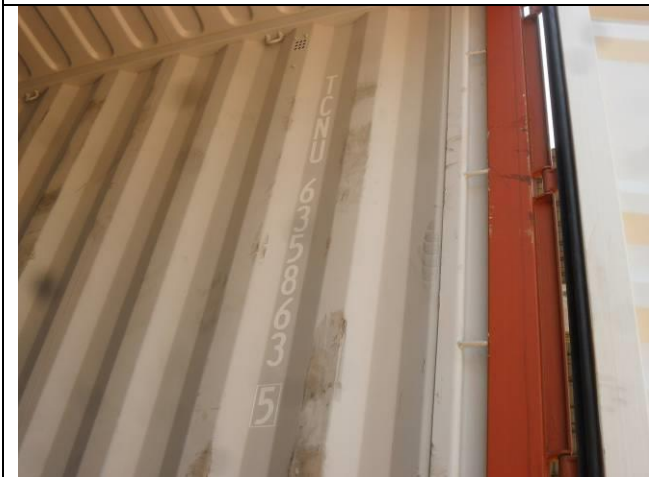
Container Number TCNU 6358635

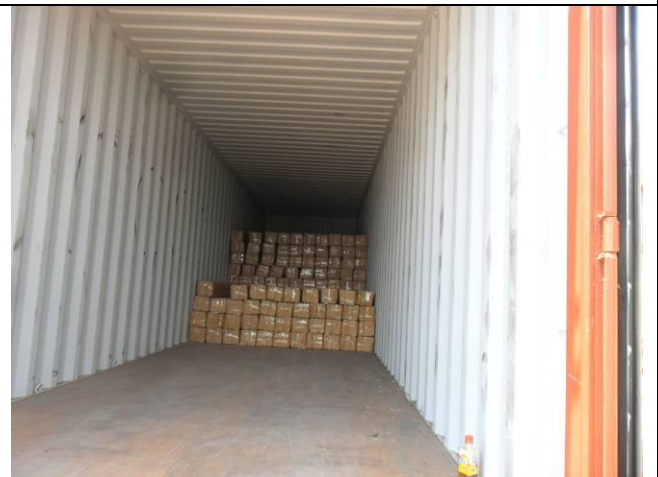
1/4 loading

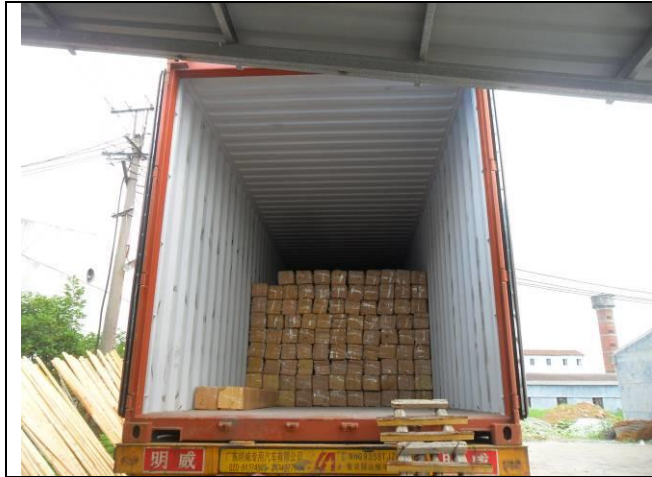
2/4 loading

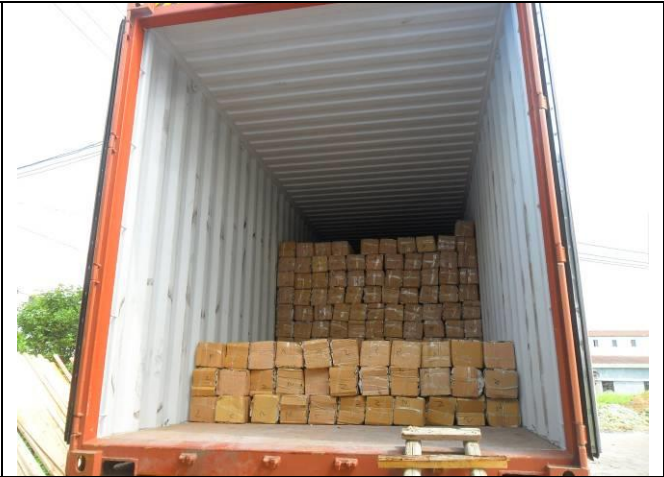
3/4 loading

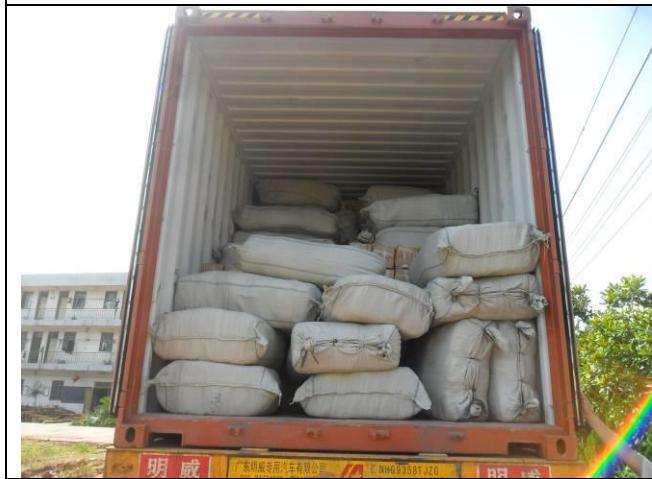
Problem Remarks:	
1.	The actual loaded quantity was 598 cartons, different from client's packing list 709 cartons. Please refer to attached packing list and section A for details.

Full loading

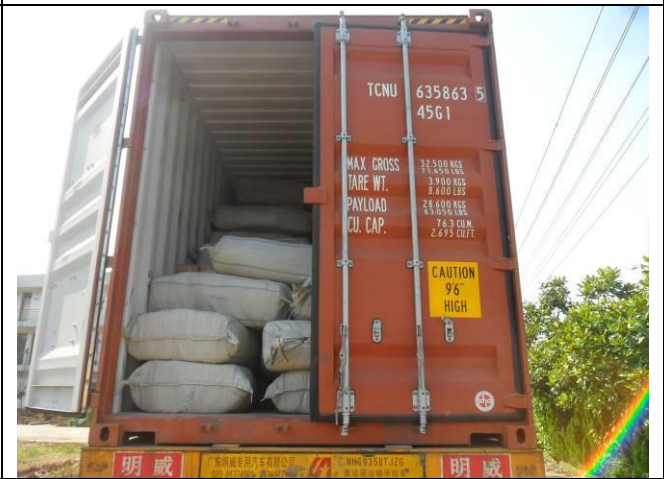
Close the right door

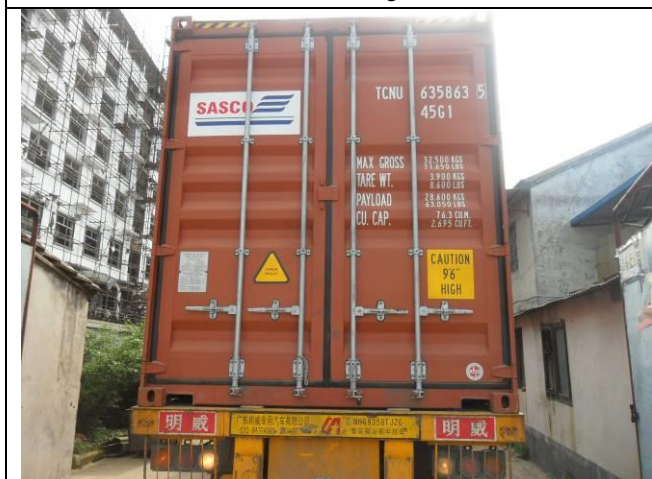
Close-up of sealed

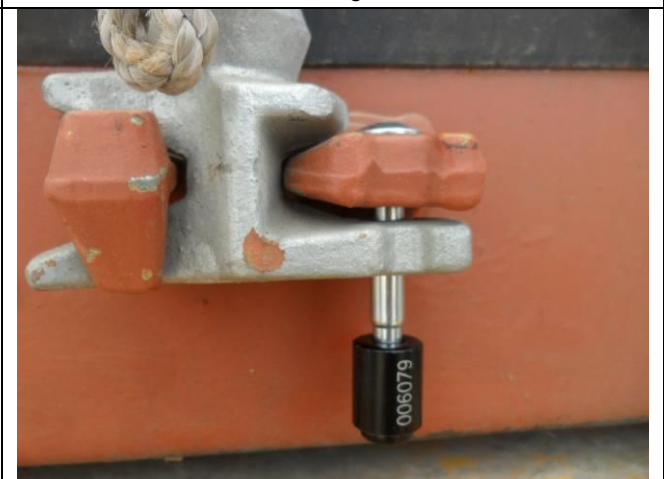
Seal number 006079
